# UPGRADE INSTRUCTIONS

PN# 25-05 | October 23, 2025

## Aircore EC: Gen4.2, Special Upgrade Instructions

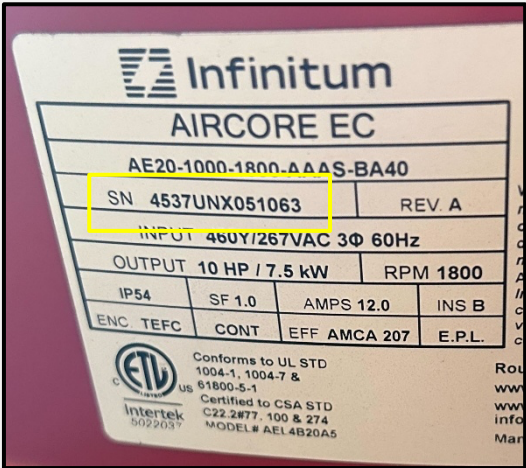
Figure 2: Serial number on motor

A serial number with the first four characters less than “4438” and currently running Gen4.1 firmware indicates an incompatible bootloader, as described in PA-25-04. The prefix “4438” corresponds to motors manufactured during Week 44 of October 2024. The Serial number can be found on the motor nameplate as shown in Figure 2.

Under these circumstances, the motor cannot be upgraded to Gen4.2 firmware in the field using I-con v2.99. Please contact Infinitum at [Support@GoInfinitum.com](mailto:Support@GoInfinitum.com) and follow the below options.
